# USO DEL MÉTODO DE IMPACTO ECO EN RESTAURACIÓN EN LA HABANA VIEJA

## USE OF IMPACT ECHO METHOD IN RESTORATION IN OLD HAVANA

the study of its performance in practical applications is less common. This is the case of Old Havana. In this paper the IEM is applied to health structure evaluation of the columns of ashlar of calcareous rocks covered with stucco based on cement in Santa Isabel Hotel, located at the eastern side of the Plaza de Armas, in Old Havana. Figure 1 shows a photo of this building; a mansion which was constructed for the Countess of San Juan de Jaruco but that was later bought by the Count of Santovenia, whose initials can be seen in the decorative iron balcony rails. It was converted into a hotel in 1867 [6]. Recently it was restored, and is now run by the Office of the City Historian of Havana through its company called Habaguanex.

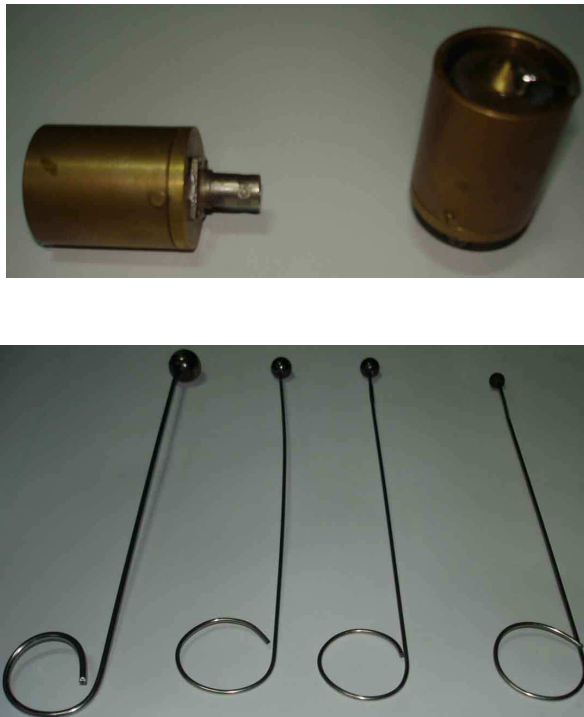
Figure 3: Photographs of the Pick up transducer and impactors.

nals, which are evaluated with the use of Fast Fourier Transform (FFT). In this case, the signal is recorded by a Tektronics oscilloscope and sent to a PC for FFT evaluation implemented with *Matlab 7.0*. A spectral pattern will be used as a clue for evaluating homogeneities in the structure. This is possible because we can compare the result with a theoretical spectral pattern obtained from FEM in a healthy column. The pick up transducer was developed using piezoceramics PZT (Figure 3).

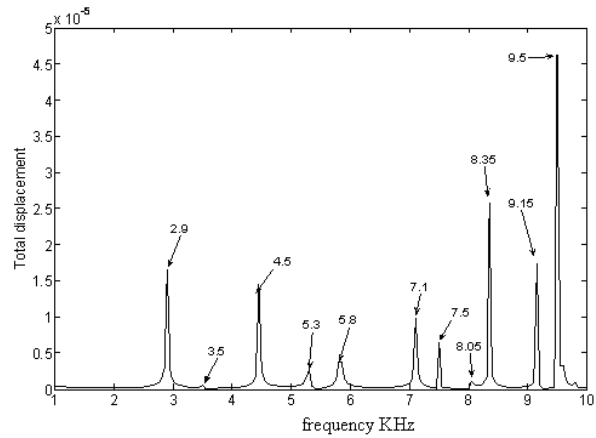
Figure 4: Harmonic analysis of a circumferential slide of the column. A plain strain condition is assumed.

Figure 4 shows the spectral pattern obtained with FEM. The peaks correspond to modals from a circumferential slide of the column with an average diameter of 45 cm [7, 8].

It is assume a plain strain condition with a longitudinal velocity of 3000 m/s, according to an ultrasonic evaluation of the material using the transmission method with 54 kHz transducers. A Poisson ratio of 0.2 and a density of 2500 kg/m<sup>3</sup> were assumed. In Figure 5 the firsts four eigenvectors are shown.

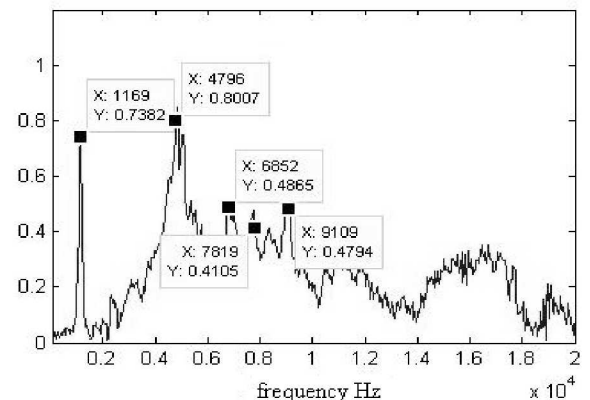
Figure 8: Spectral pattern in the column with visual cracks. X is frequency value and Y relative amplitude.

In Figure 8 we show a spectral pattern of the columns with visual cracks (Figure 6). In this case there is a different spectral pattern compared with the previous cases. A peak frequency of 1169 Hz appears.

This low frequency could be interpreted as laminations of the stucco vibrating in a flexural mode. Then, it was possible to evaluate the interior of this column, “in good condition”, and only the stucco has to be repaired.
